Bank of America Building Assessment

Location:
Norfolk, VA

This was an investigation of the exterior structural condition of the 2nd, 3rd and 4th floor concrete beams and columns spalls and cracks.

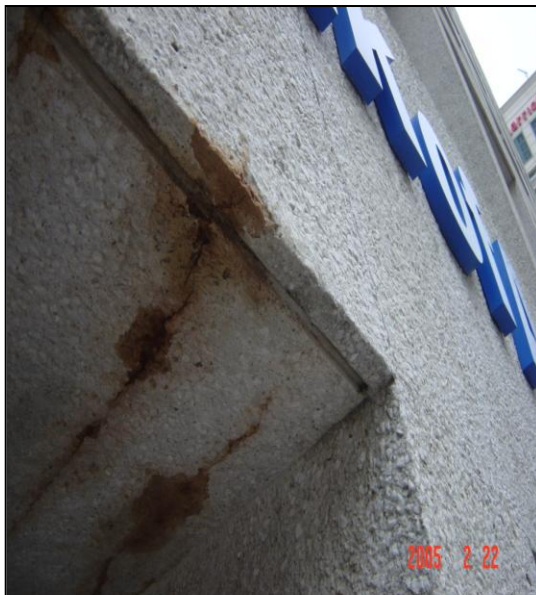
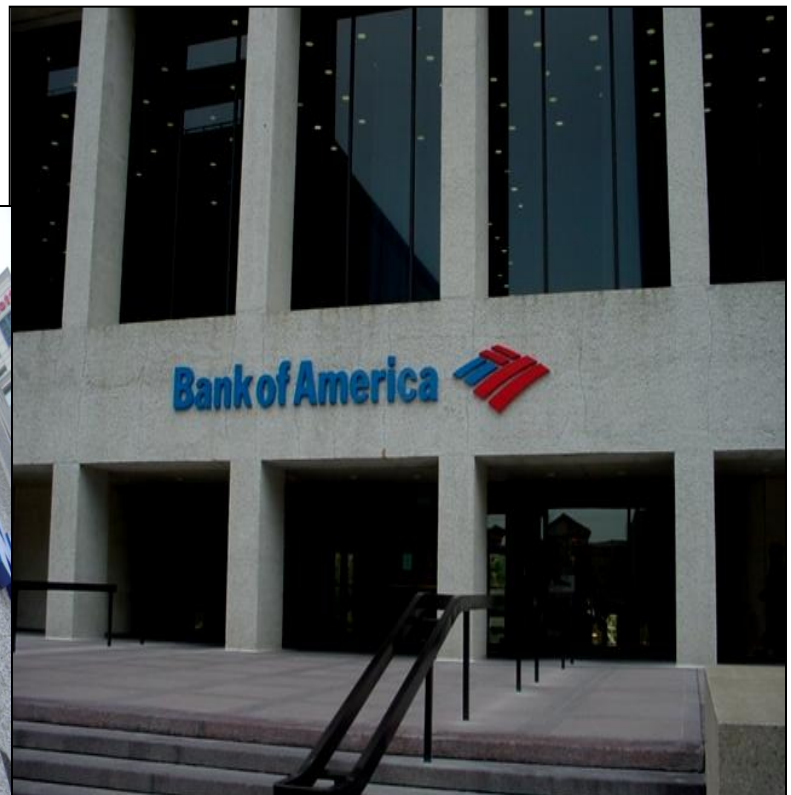
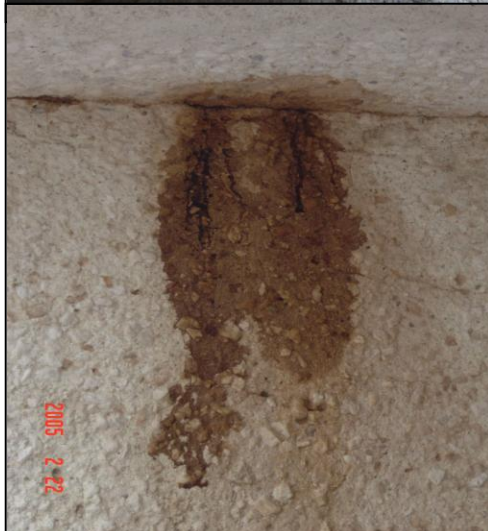
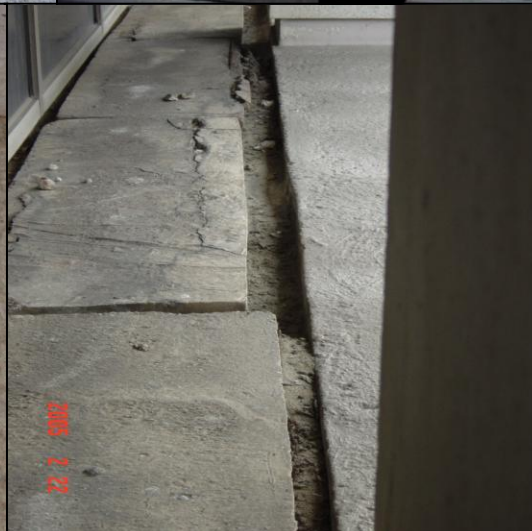
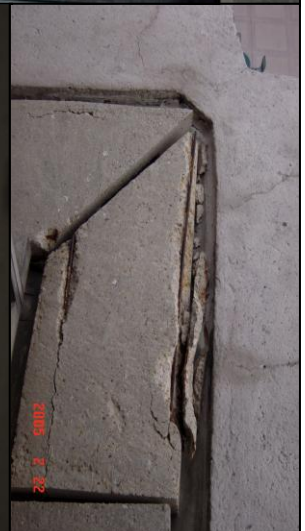
The purpose of this study was to perform a survey and to document cracks and spalls that were visible during the building survey. Also as part of this report, we included methods of structural repairs of the cracks and concrete spalls.
